Re: Cedar Chemical Corporation Consent Administrative Order

**WELL ASSESSMENT REPORT
CEDAR CHEMICAL COMPANY
WEST HELENA, ARKANSAS**

August 6, 2007

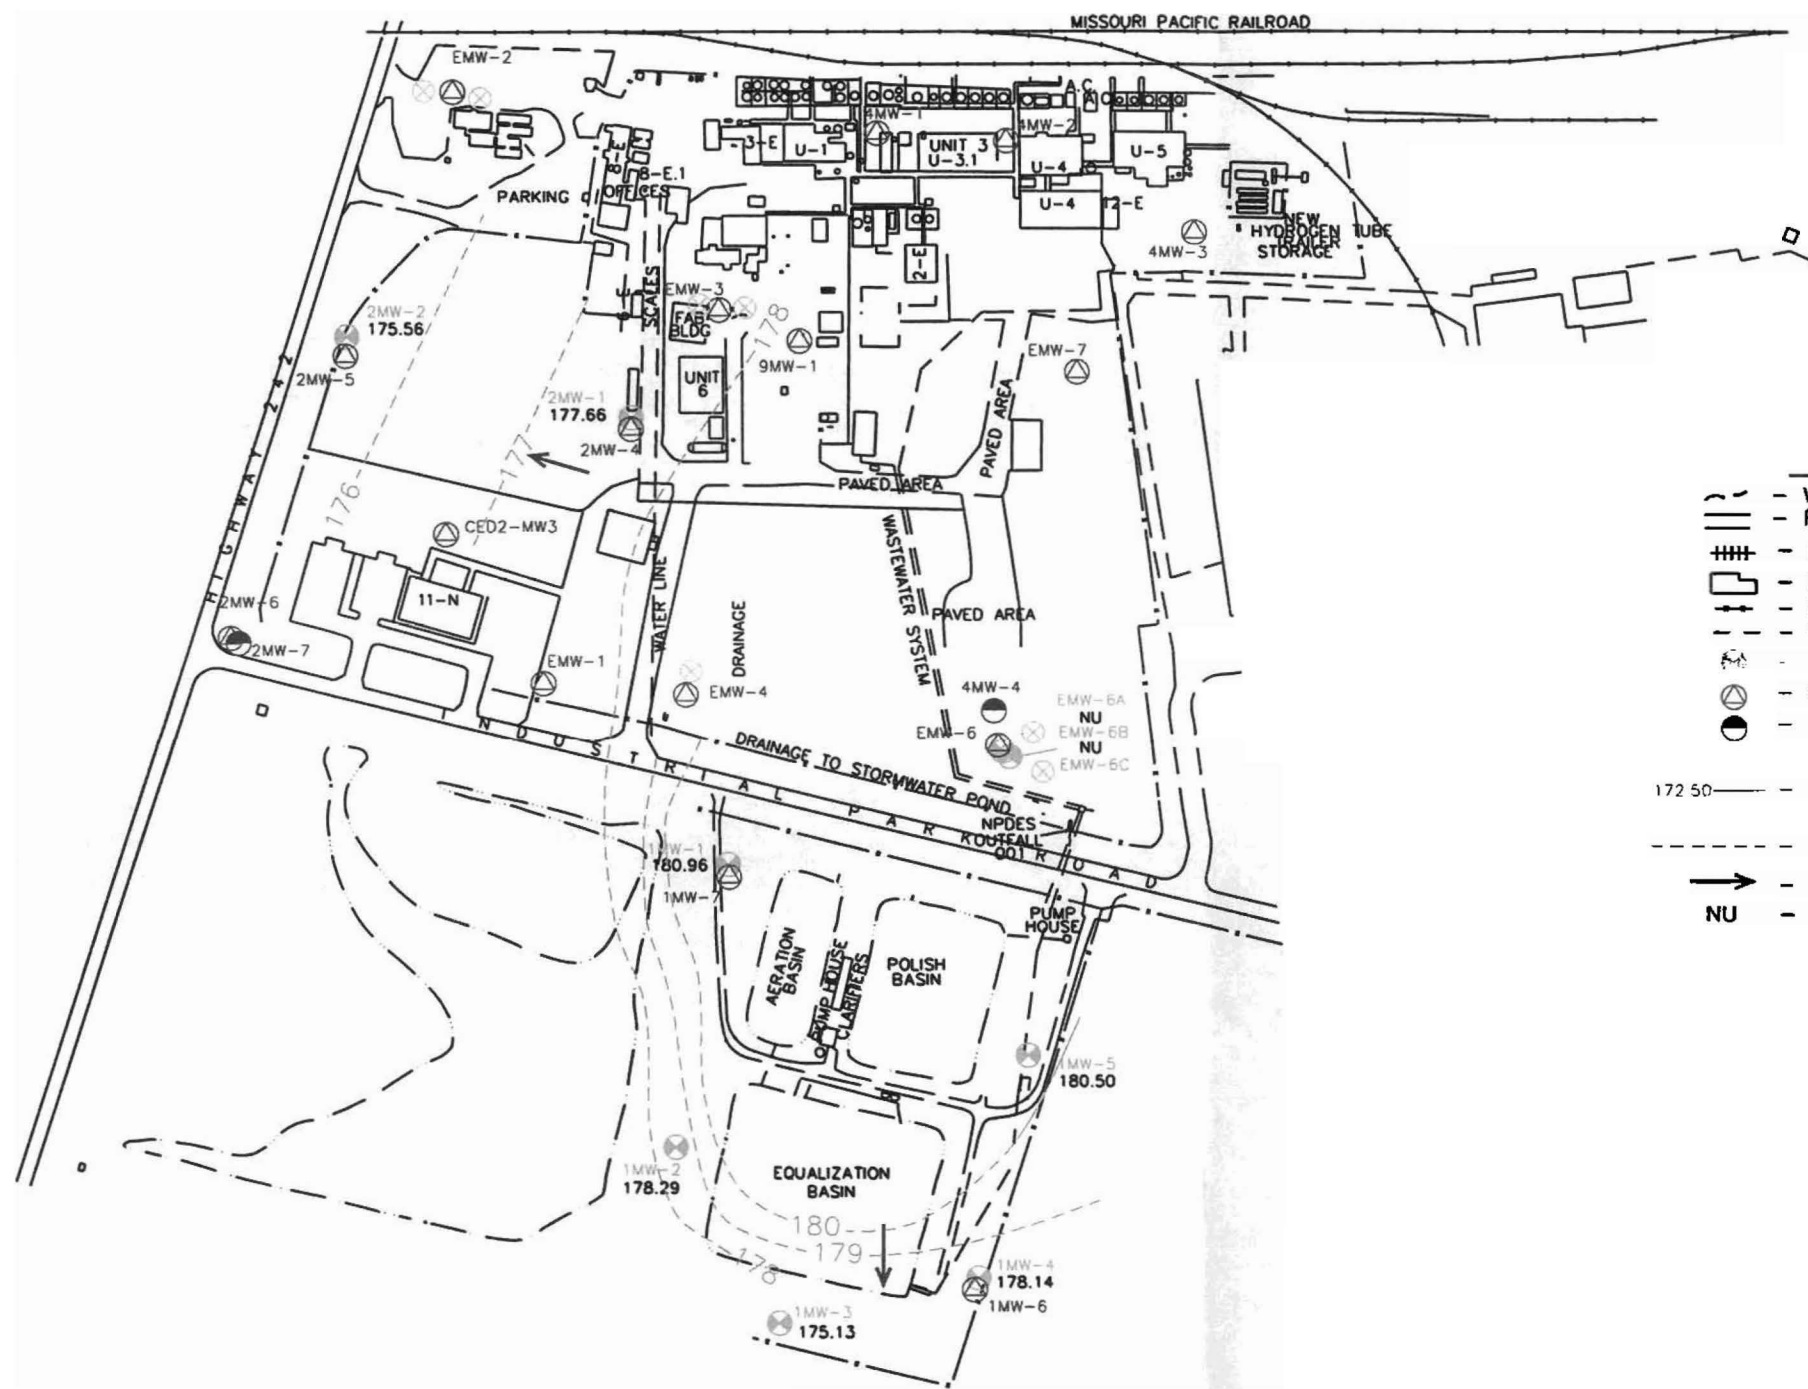
FIGURE 2
POTENTIOMETRIC SURFACE MAP OF THE
PERCHED ZONE
CEDAR CHEMICAL
WELL ASSESSMENT REPORT

A piezometric surface map in Figure 2 in Appendix A of the perched zone shows a radial flow in the area of the WWTP equalization, polish, and aeration basins. The groundwater appears to flow generally to the west and south away from the WWTP area. There is little to no well coverage in the perched zone over the north half of the site, and consequently no contours are presented. The static water levels recorded in 7 wells in this aquifer ranged from 170.13 to 180.96 feet above the North American Vertical Datum (NAVD).

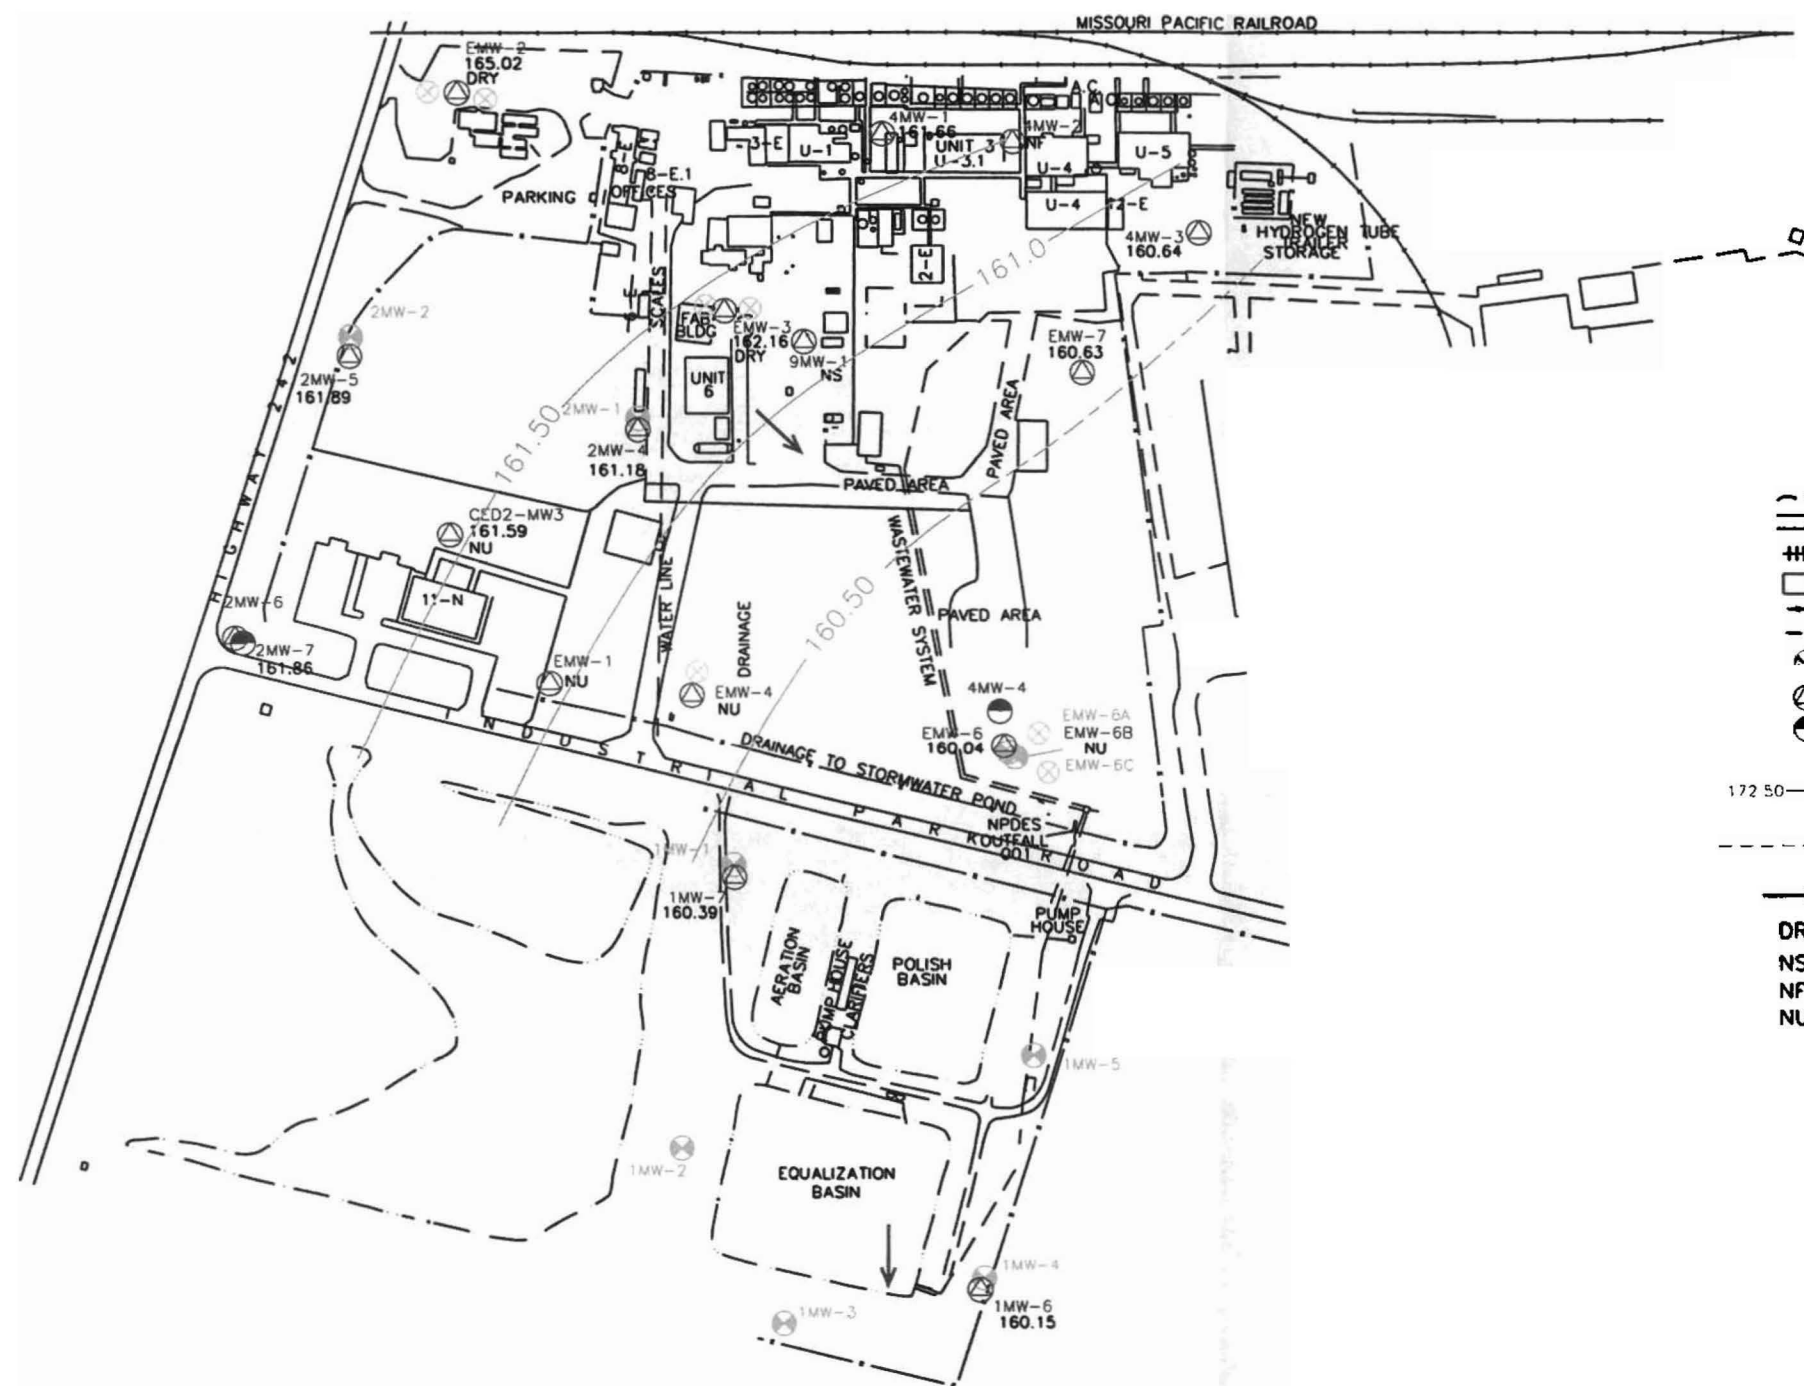
FIGURE 3
POTENTIOMETRIC SURFACE MAP OF THE
UPPER ALLUVIUM (SHALLOW)
CEDAR CHEMICAL
WELL ASSESSMENT REPORT

A piezometric surface map in Figure 3 in Appendix A of the upper alluvial zone shows an even flow pattern with the direction of the flow to the east-southeast. The well coverage is good across the site despite the fact that a few of the wells were not used due to uncertain elevations and condition. The static water levels recorded in 12 wells in the upper alluvial aquifer ranged from 161.89 to 160.04 feet above the NAVD.

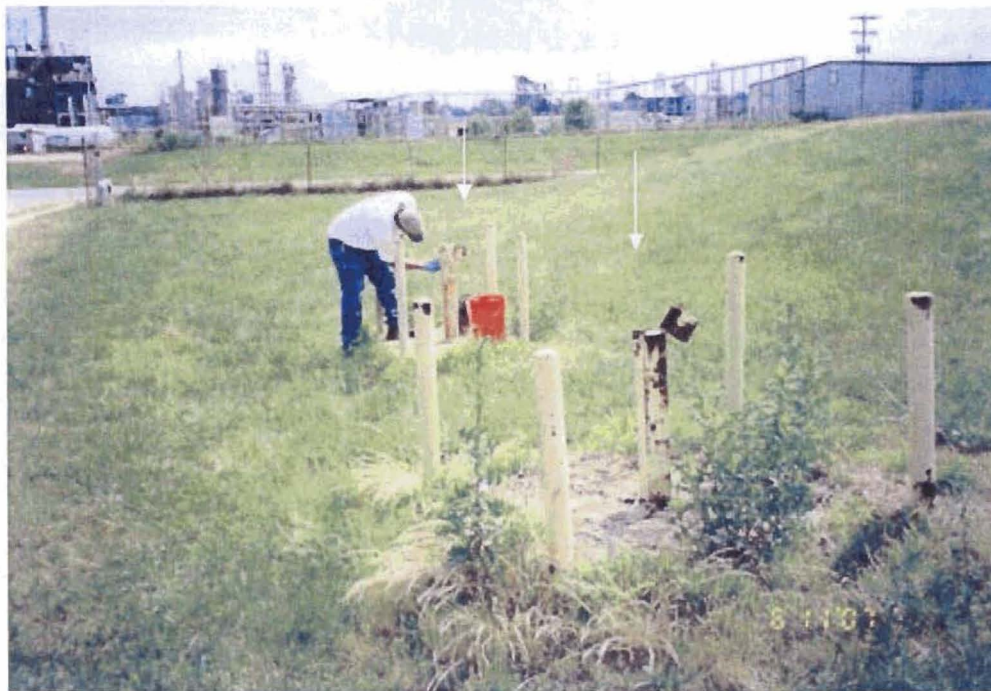
Photo 1: View of wells 1MW-1 (background) and 1MW-7 (foreground).

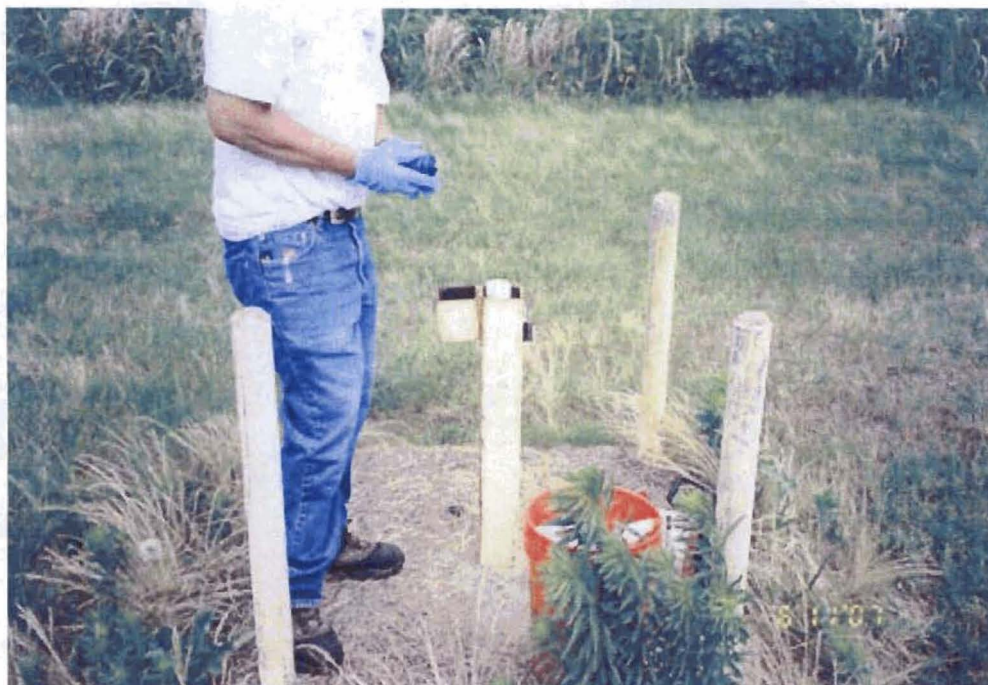
Photo 2: View of well 1MW-2.

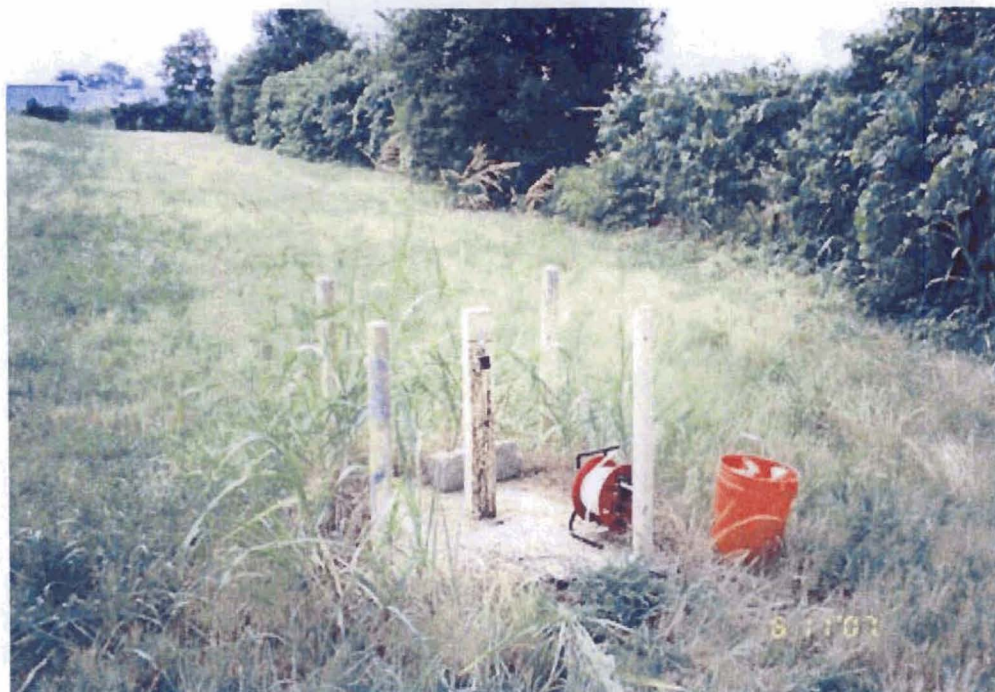
Photo 3: View of well 1MW-3.

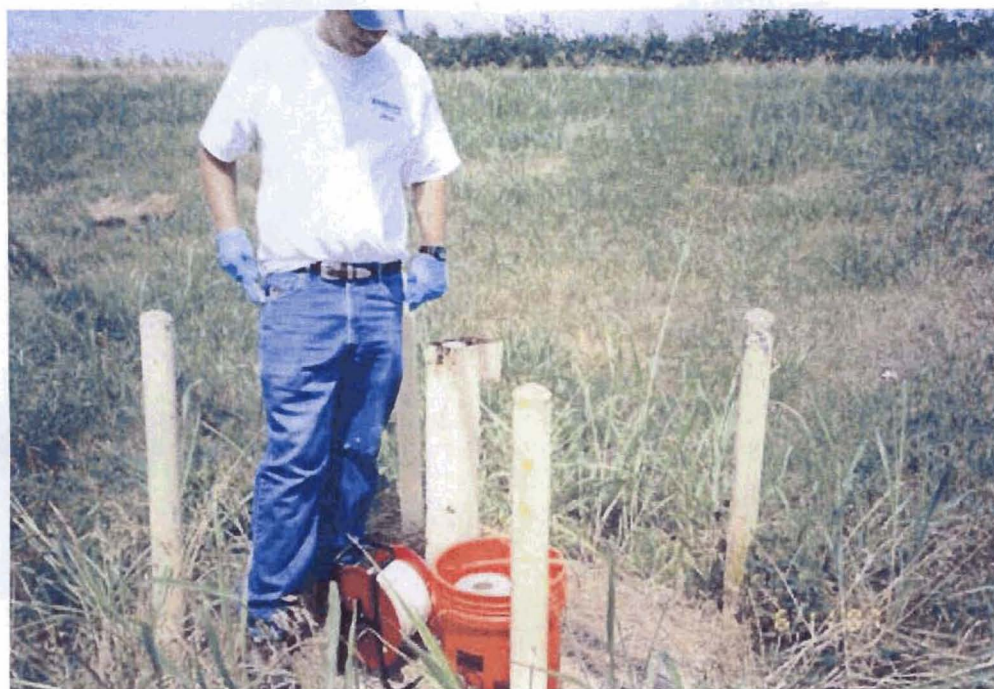
Photo 4: View of well 1MW-5.

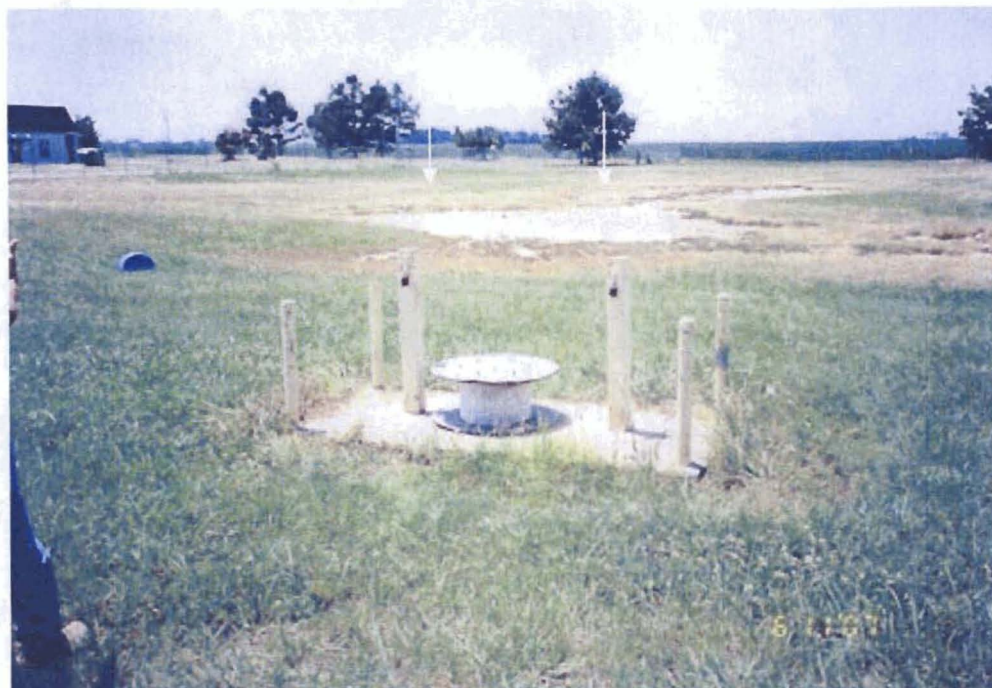
Photo 5: View of wells 2MW-4 (left) and 2MW-1 (right).

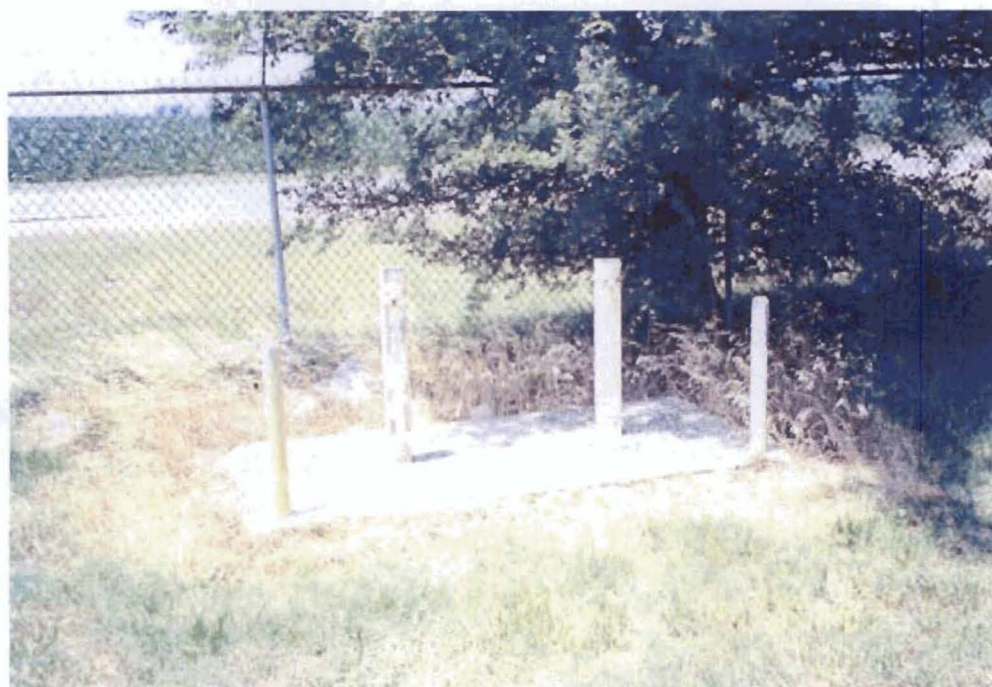
Photo 6: View of wells 2MW-5 (left) and 2MW-2 (right).

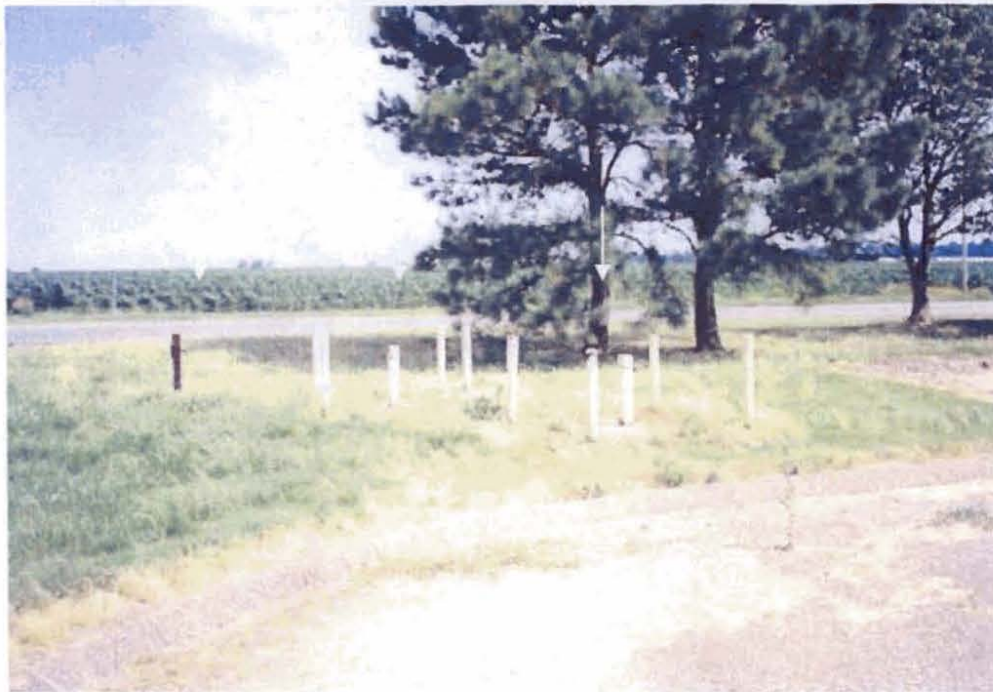
Photo 7: View an unidentified well (far left) and wells 2MW-6 (middle) and 2MW-7 (right).

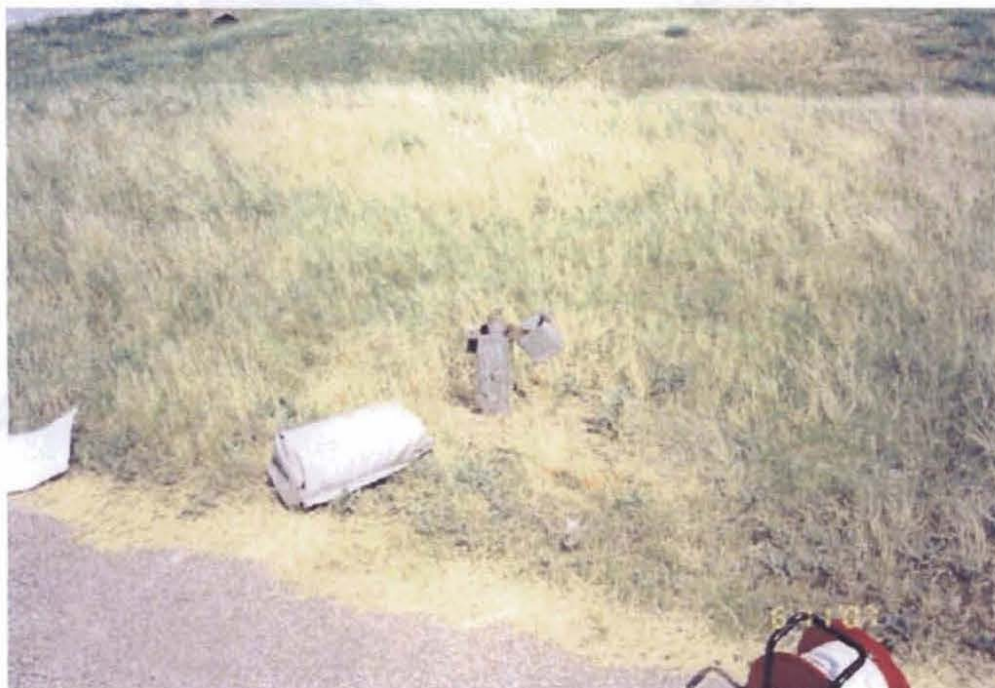
Photo 8: View of well EMW-1.

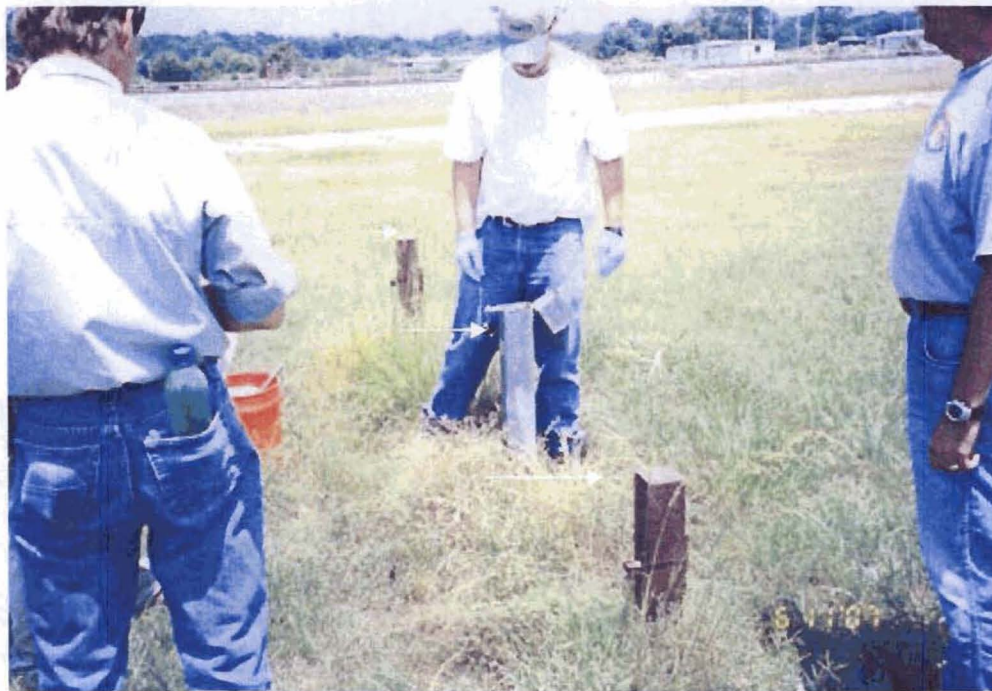
Photo 9: View of two unidentified wells (foreground and background) and well EMW-2 (middle).

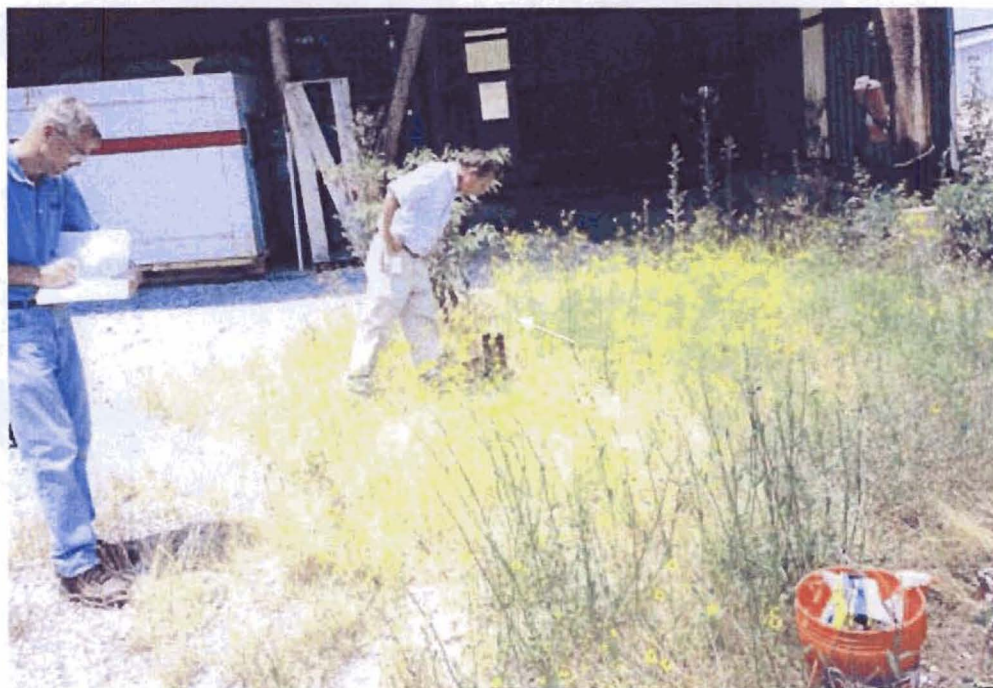
Photo 10: View of well EMW-3.

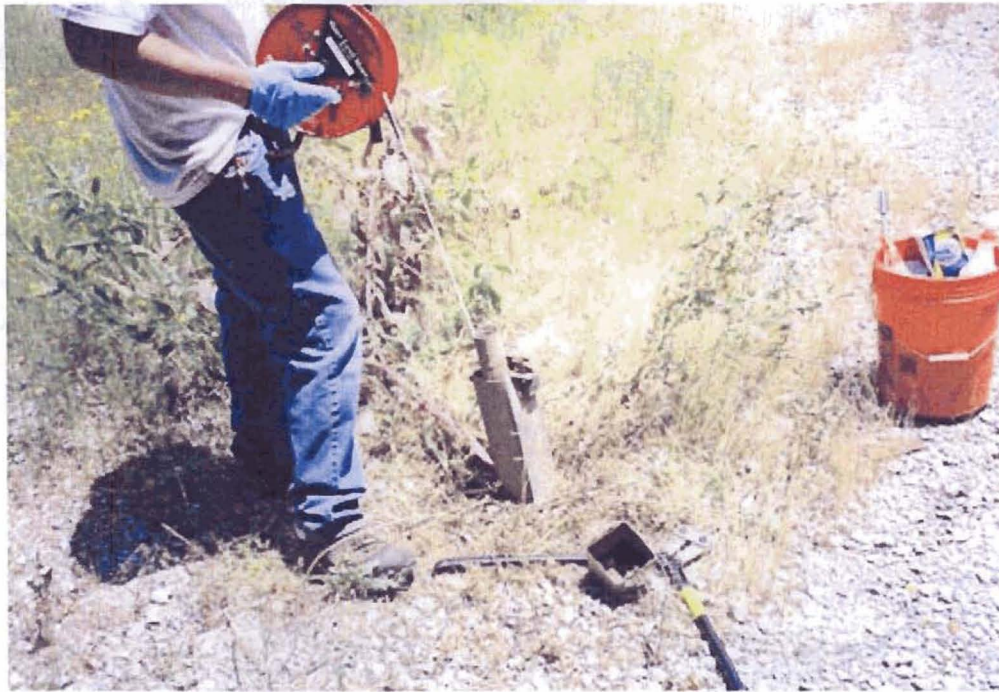
Photo 11: Close-up view well EMW-3.

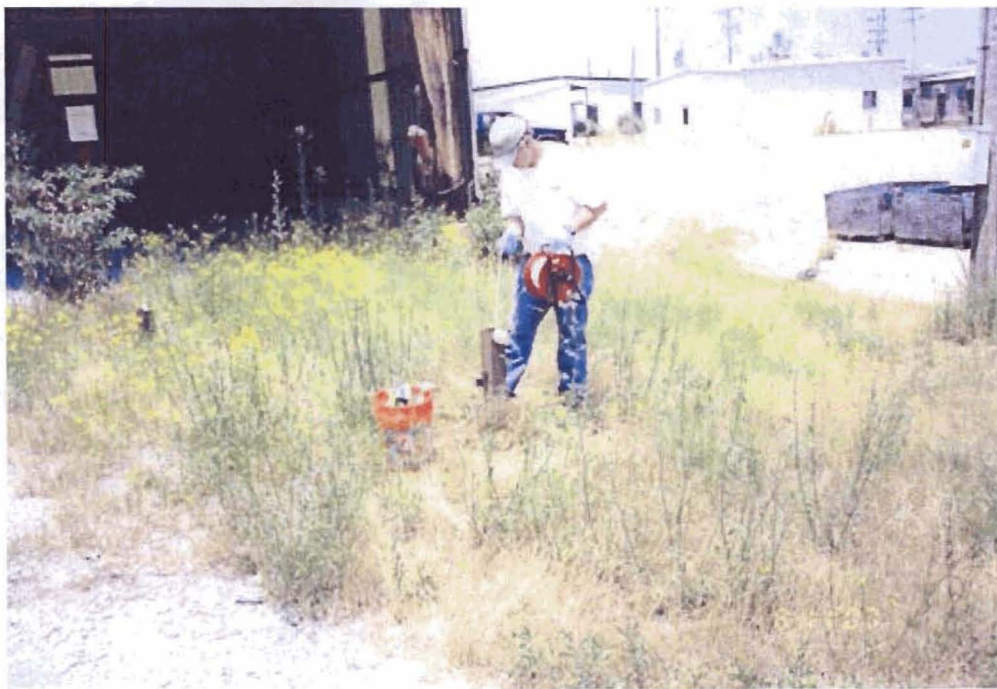
Photo 12: View of an unidentified well near EMW-3.

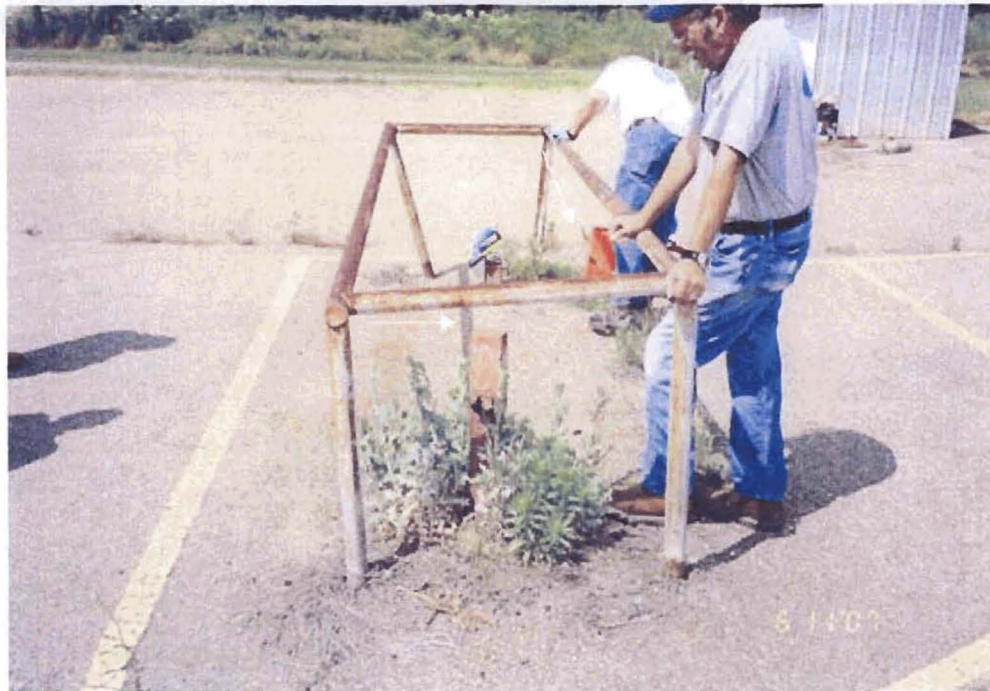
Photo 13: View well EMW-4 (background) and an unidentified well (EMW-4b) located north of EMW-4 (foreground).

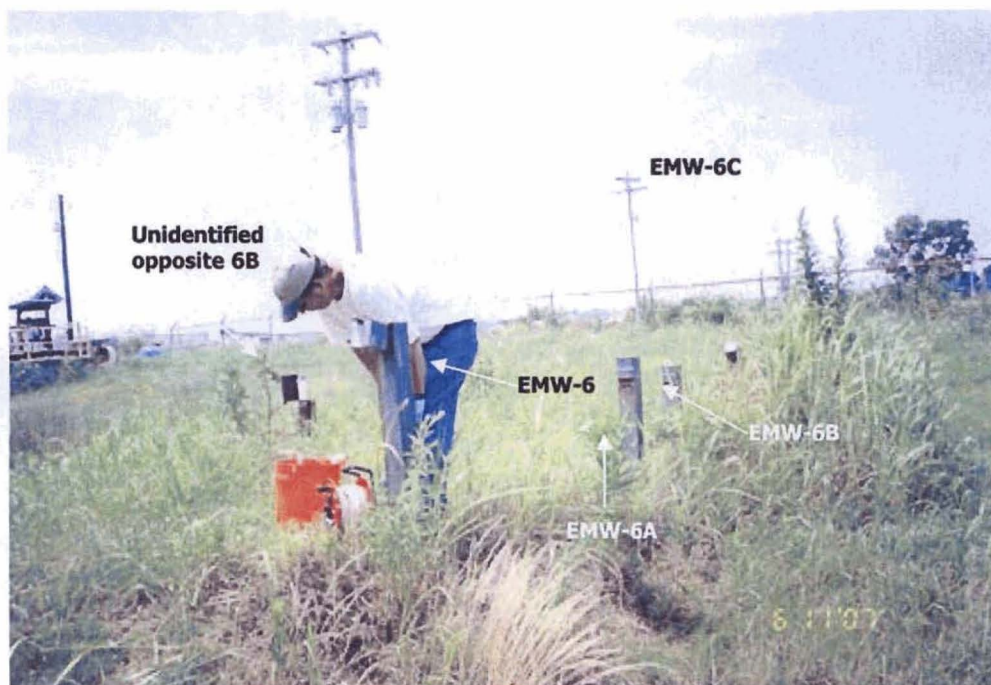
Photo 14: View wells EMW-6, EMW-6A, EMW-6B, EMW-6C, and an unidentified well.

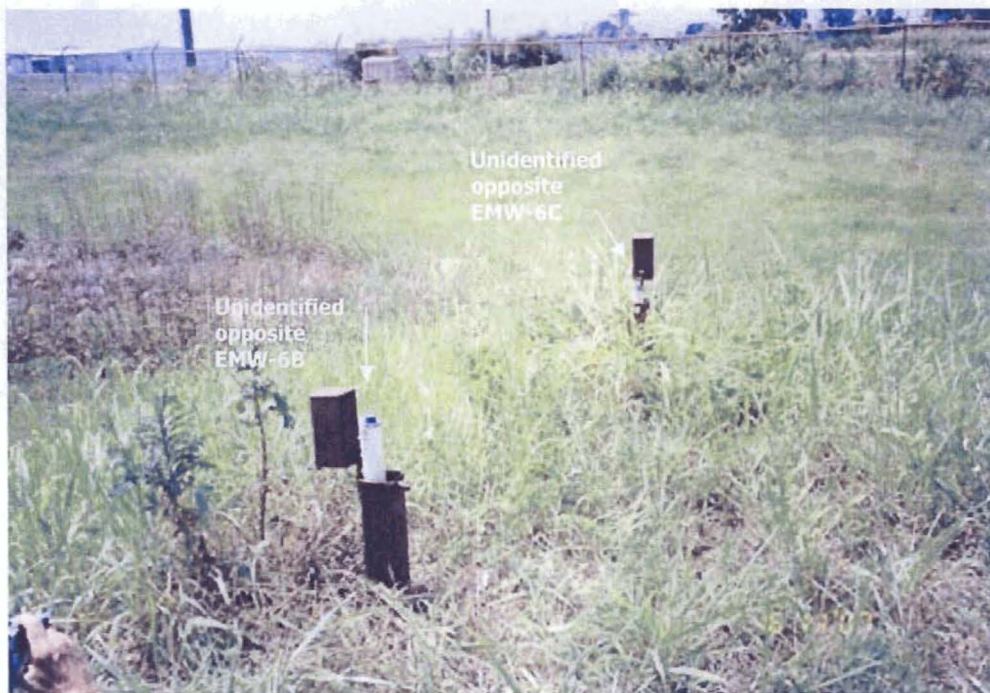
Photo 15: View of an unidentified well opposite EMW-6B and one opposite EMW-6C.

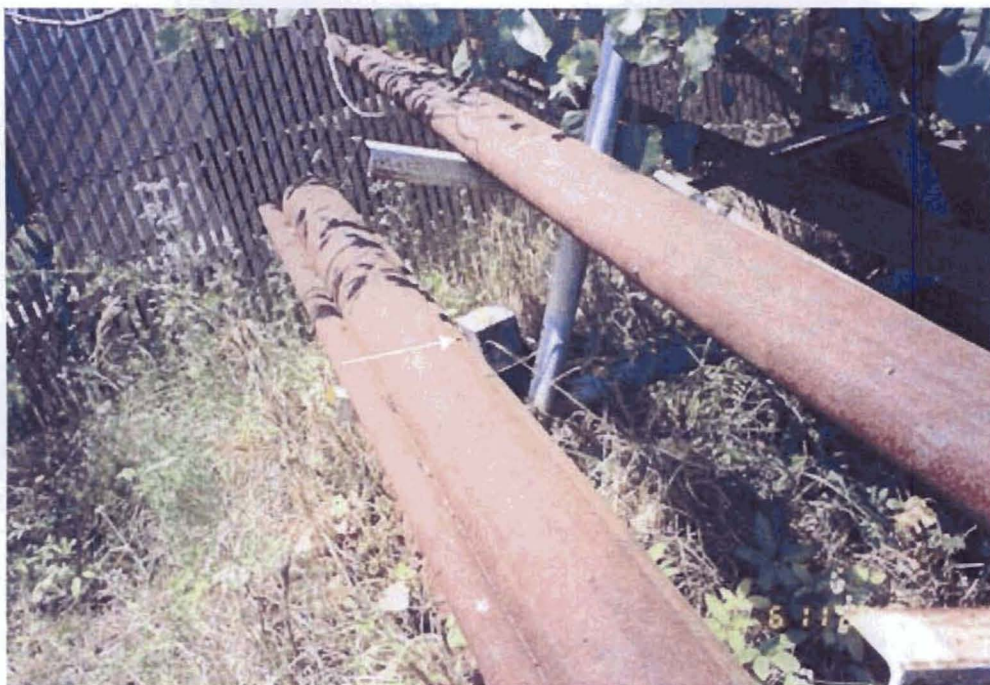
Photo 16: View of well EMW-7.

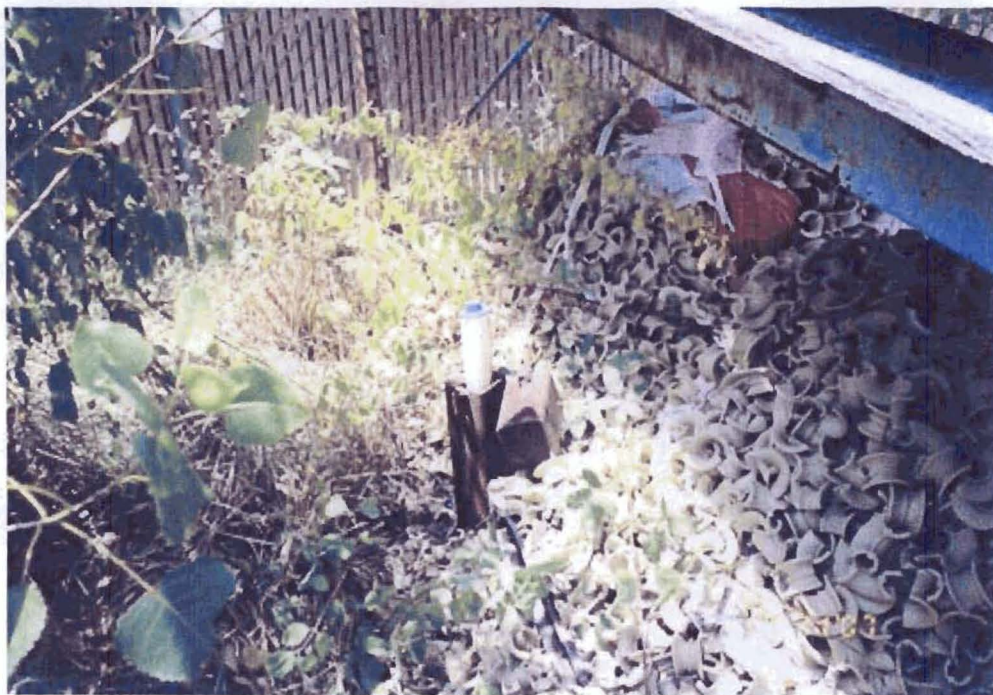
Photo 17: View of unidentified well opposite EMW-7.

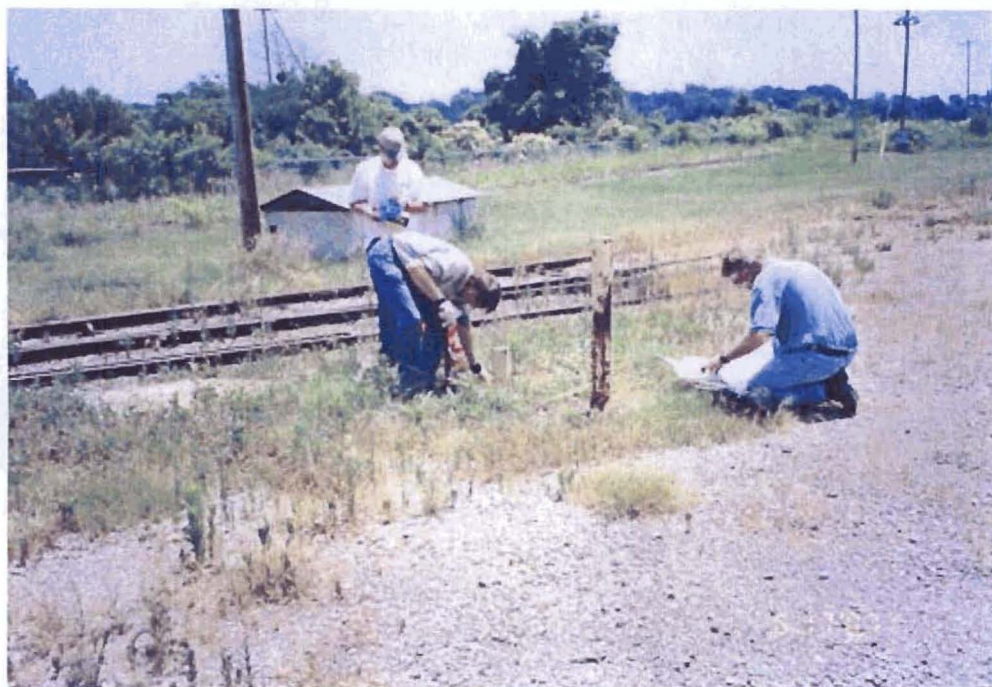
Photo 18: View of unidentified well northeast of Unit 5 at railroad spur.

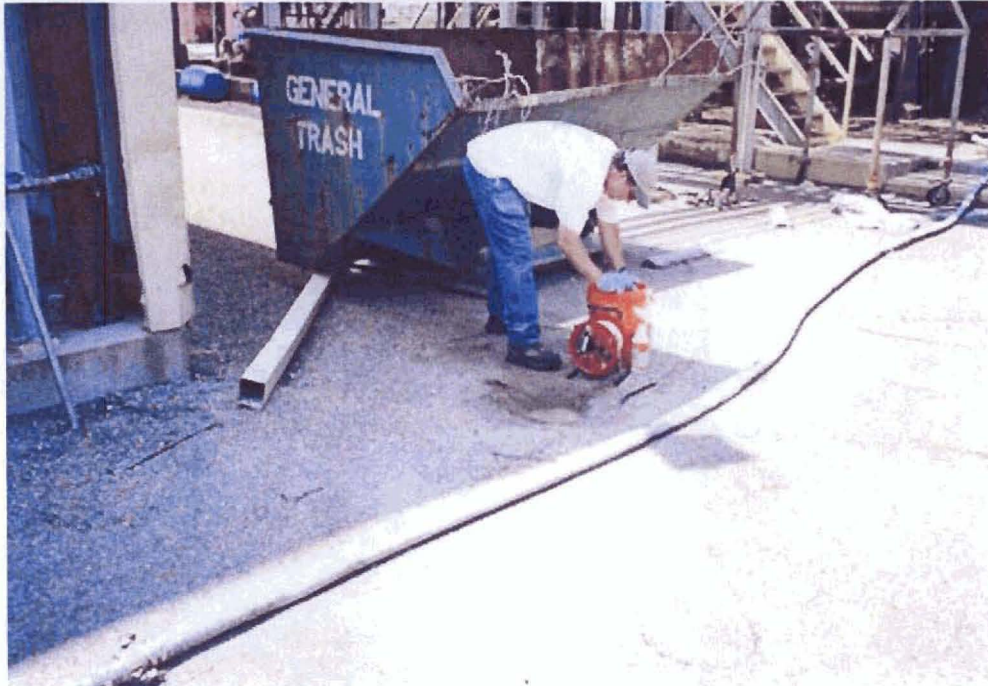
Photo 19: View of well 4MW-1.

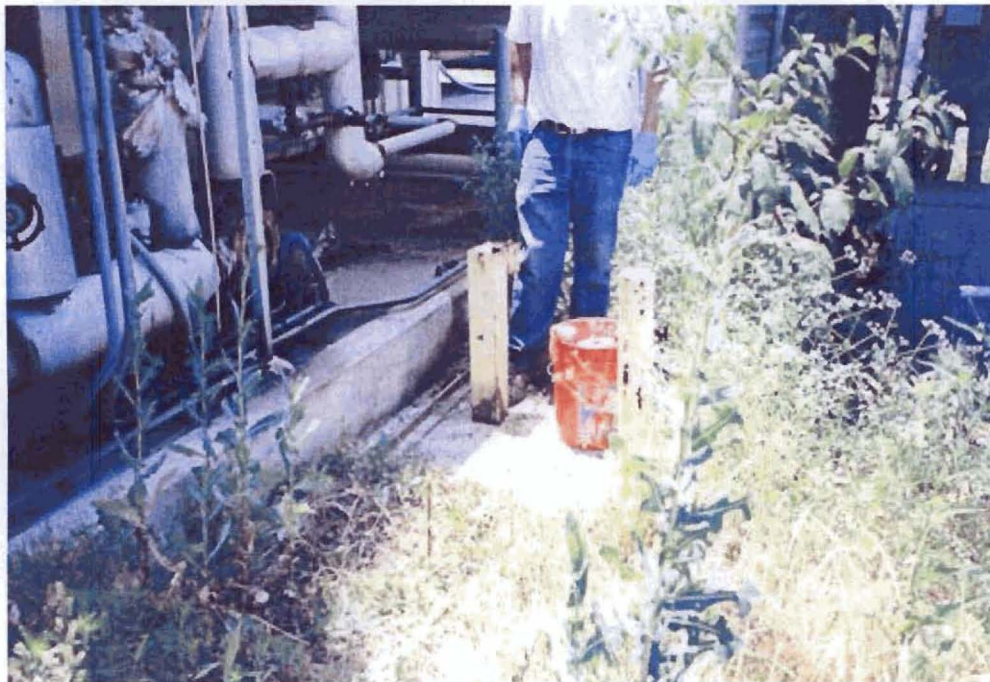
Photo 20: View of well 4MW-3.

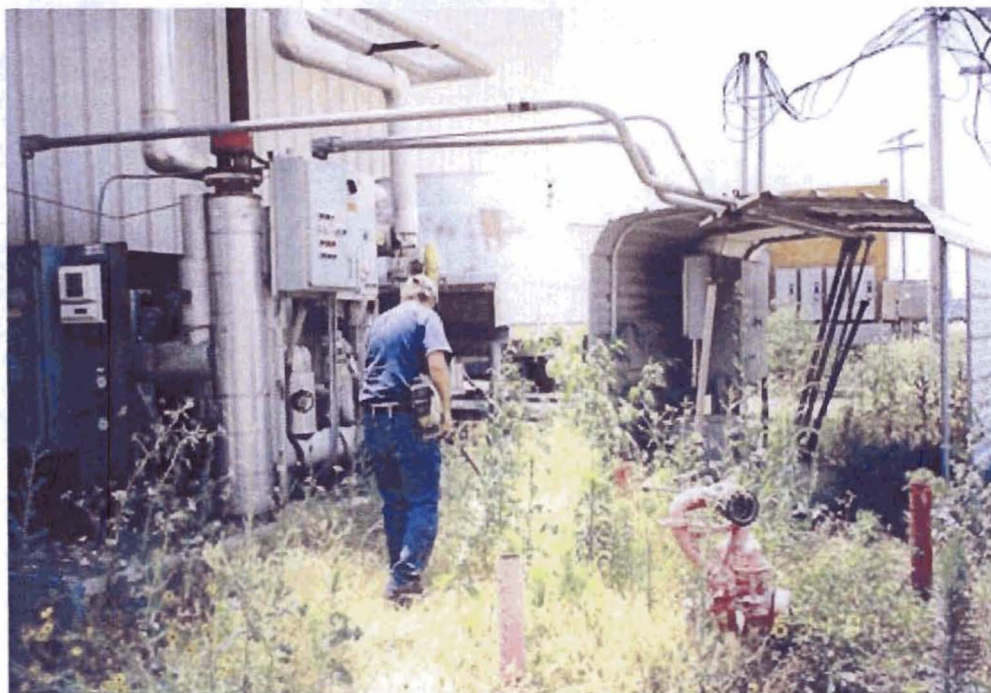
Photo 21: Clearing brush around well 4MW-3.

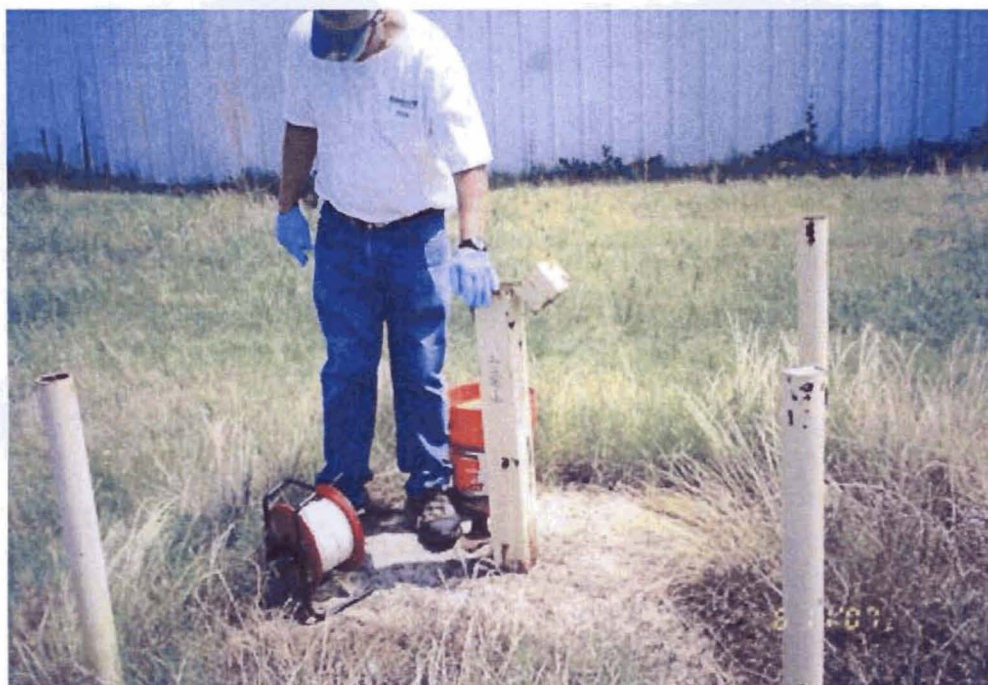
Photo 22: View of well 4MW-4.

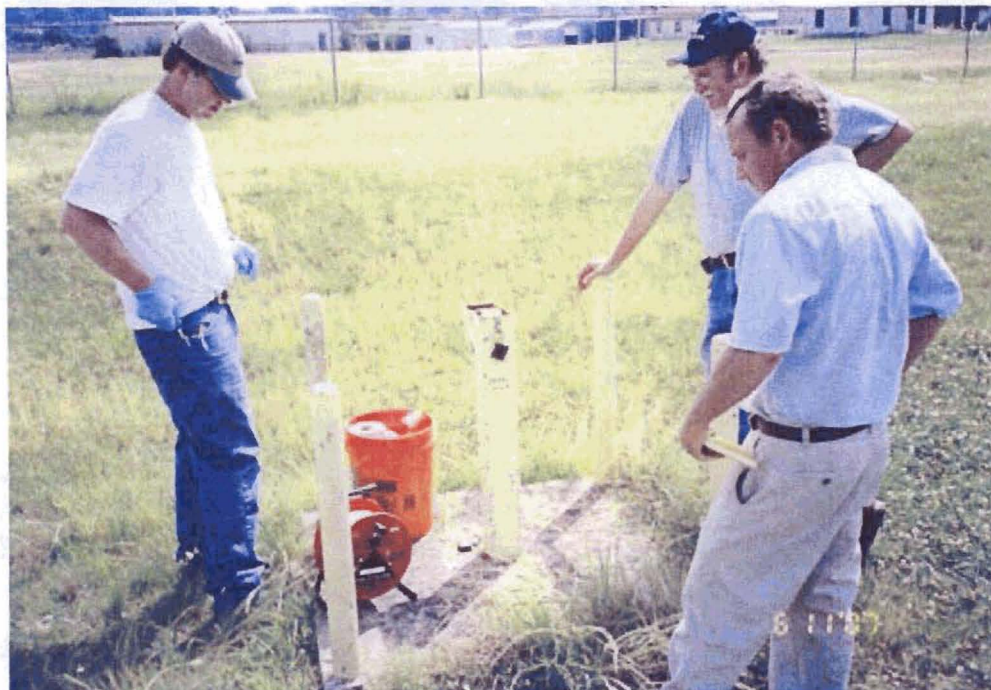
Photo 23: View of well CED2-MW3.

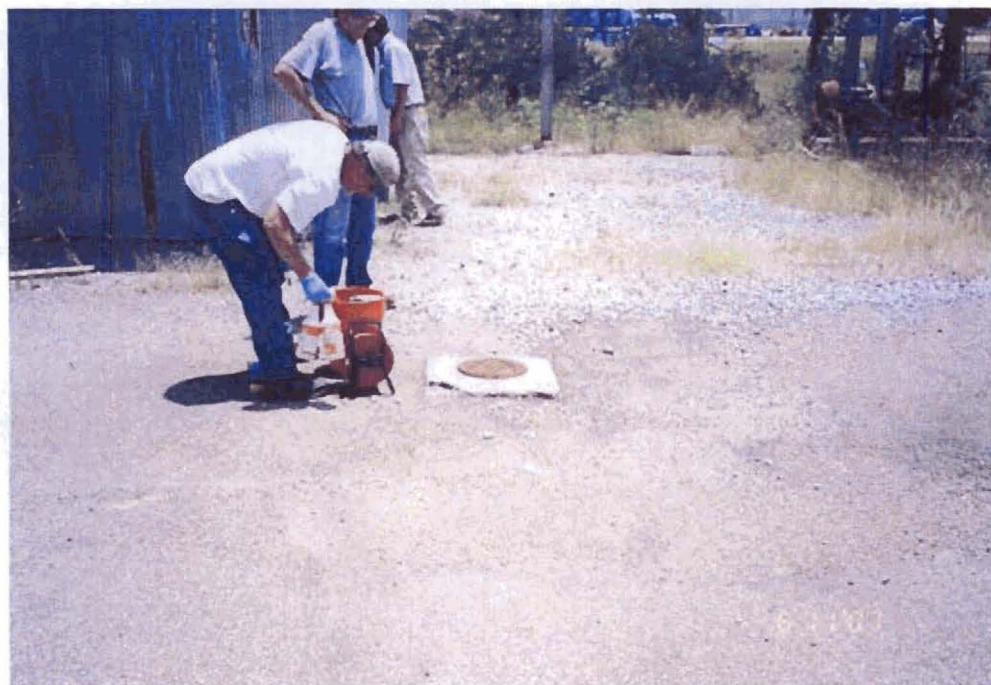
Photo 24: View of well 9MW-1.
